Diamond Head Consulting Ltd. Arborist Report

**1946-1998 Glenaire Dr
North Vancouver, BC**

July 28, 2017

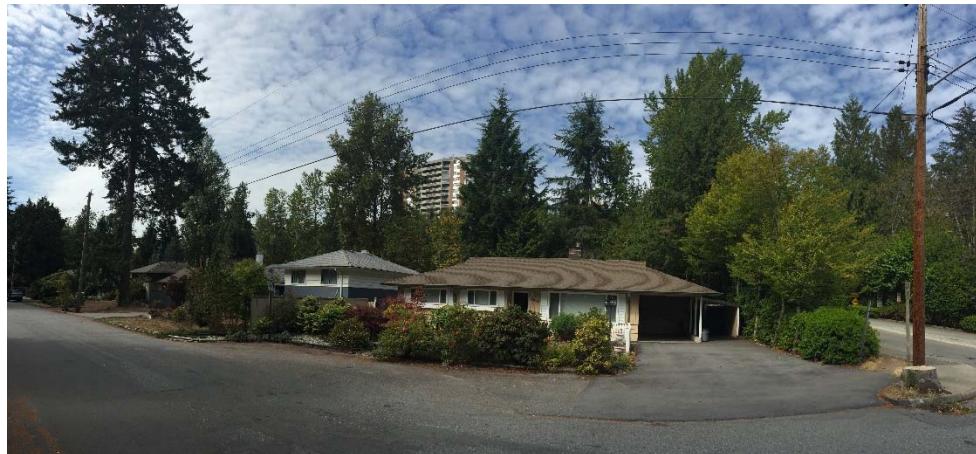
Photo 1. View north over existing residences at mature trees growing adjacent to the backs of the lots.

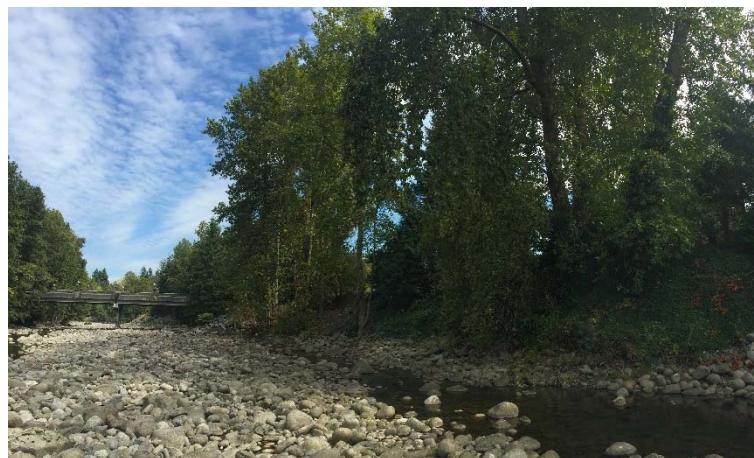
Photo 2. View of riparian buffer from the river.

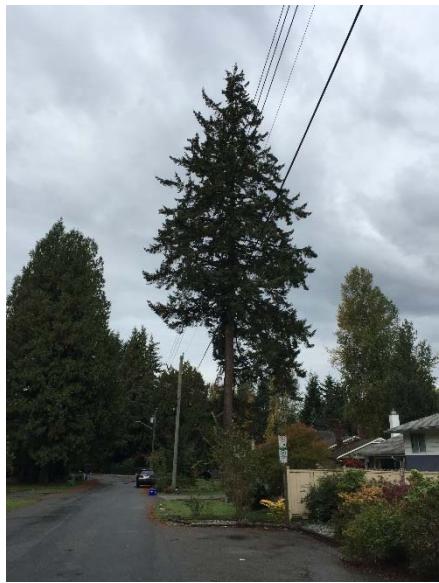
Photo 3. View of tree 3947

3947	Douglas-fir	<i>Pseudotsuga menziesii</i>	104	41	70-79%	Excellent	Suitable	Open grown full crown. Between two driveways with roots cracking asphalt to the west. Large size tree. This tree is in conflict with the proposed parkade excavation.	Remove	8	8.5
3954	Western Hemlock	<i>Tsuga heterophylla</i>	33	15	50-59%	Poor	Unsuitable	Previously topped at 8m. Decay at crotch of old topping. 1m from shed. This tree is in conflict with the proposed parkade excavation.	Remove	3.3	3.5
3955	Western Hemlock	<i>Tsuga heterophylla</i>	31	14	60-69%	Poor	Unsuitable	Previously topped at 8m. Decay at crotch of old topping. 1m from shed. This tree is in conflict with the proposed parkade excavation..	Remove	3.1	3.3

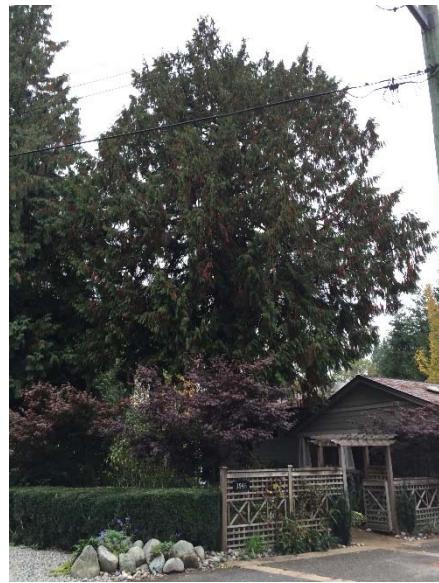
Photo 4. View of tree 3982

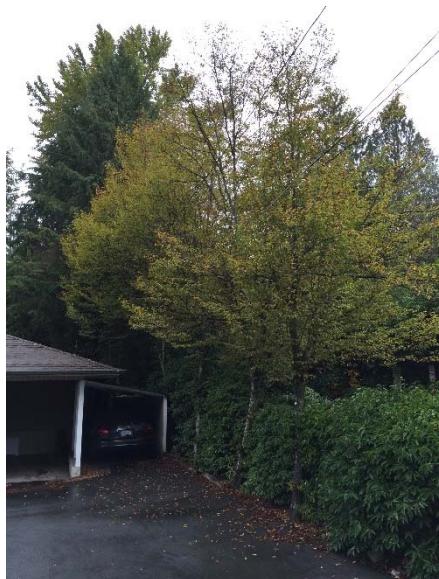
Photo 5. View of trees 3948-3952

Tag #	Common Name	Botanical Name	DBH (cm)	Ht (m)	Live Crown Ratio (%)	Overall Condition	Suitability	Comments	Retain/ Remove	Tree Protection Zone (m) from center of tree	Tree Protection Zone (m) from outer edge of tree
Off Site 3948	Hornbeam	<i>Carpinus Sp</i>	14	8	70-79%	Normal	Suitable	Growing up against driveway. Minor decay in stem at base. District owned tree. This tree is in conflict with the proposed parkade excavation.	Remove	1.4	1.5
Off Site 3949	Hornbeam	<i>Carpinus Sp</i>	17	9	70-79%	Normal	Suitable	Growing up against driveway. Minor decay in stem at base. District owned tree. This tree is in conflict with the proposed parkade excavation.	Remove	1.7	1.8
Off Site 3950	Hornbeam	<i>Carpinus Sp</i>	17	9	70-79%	Normal	Suitable	Growing up against driveway. District owned tree. This tree is in conflict with the proposed parkade excavation.	Remove	1.7	1.8
Off Site 3951	Hornbeam	<i>Carpinus Sp</i>	19	9	70-79%	Normal	Suitable	Growing up against driveway. District owned tree. This tree is in conflict with the proposed parkade excavation.	Remove	1.9	2

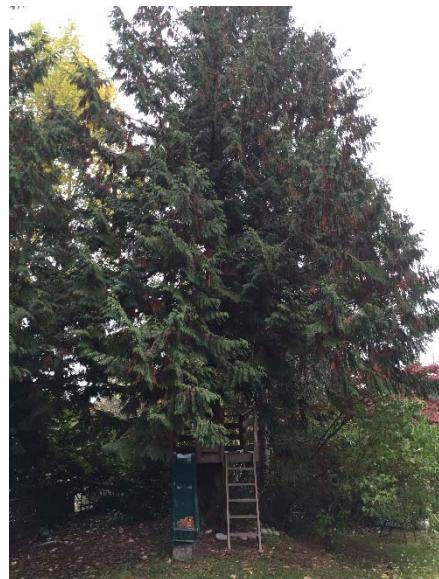
Photo 6. View of tree 472 with tree house
