HASTINGS CREEK WATERSHED:

Ecology and Hydrotechnical Assessment

June 2013

Prepared for: **District of North Vancouver**

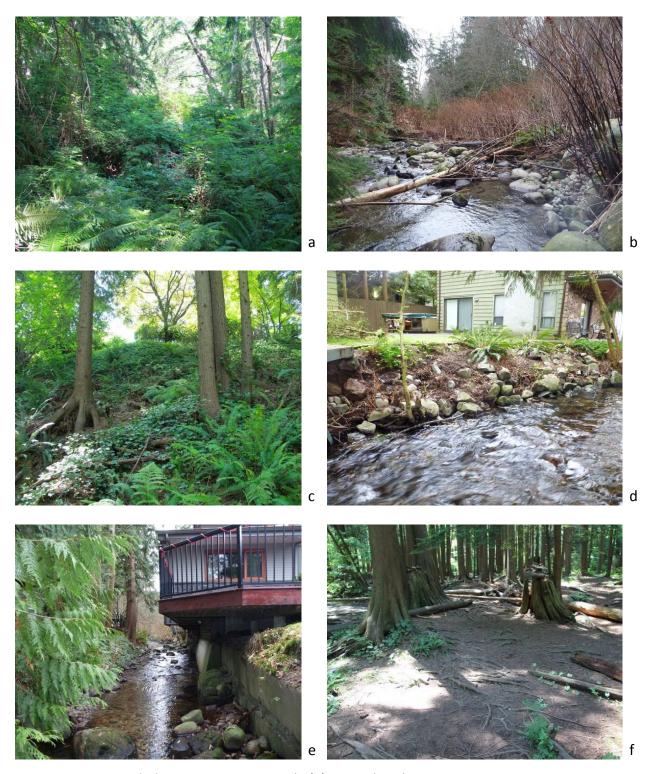
Figure 2-3. Riparian habitat in Hastings Creek: (a) natural understory vegetation in ravine section of Hastings Creek; (b) Japanese knotweed infestation along Hastings Creek near Carmaria Court; (c) English ivy and yellow lamium extending from yard edge into Hastings Creek ravine; (d and e) examples of yard encroachment through central Lynn Valley; and (f) sparse understorey vegetation and compacted soils in Hunter Park due to heavy recreational use.

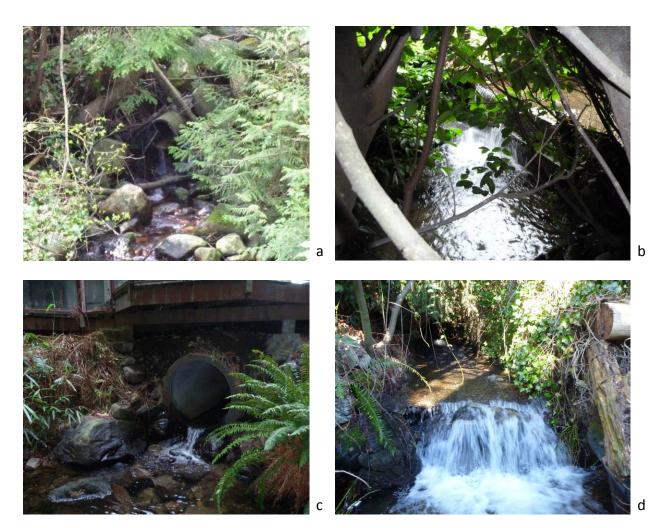
Additional barriers include: (1) an old timber dam on Hastings Creek at footbridge in Princess Park; (2) two dams below each of the Twin Lakes on Hastings Creek (above Princess Ave); (3) a wood weir dam on Coleman Creek (downstream of Lynn Valley Rd and confluence with Thames Creek).

Figure 2-7. Fish passage barriers in the Hastings Creek watershed: (a) one of two Twin Lakes dams showing outfall into Hastings Creek below; (b) outfall of culvert under Argyle School and houses on Kilmer Creek; (c) wood weir dam on Coleman Creek downstream of Lynn Valley Rd; and (d) elevated culvert and concrete apron on Thames Creek at Lynn Valley Rd.

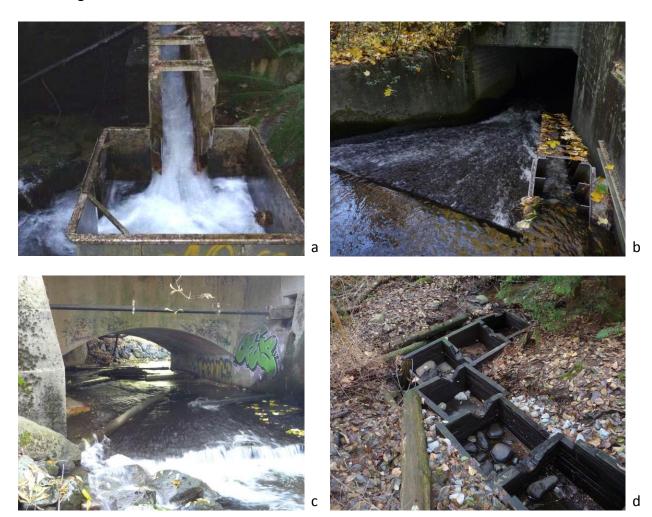
and need replacement or another fish passage solution installed at this location. The fish ladder on Donovan Pond is reported to be sinking and requires maintenance (North Shore Streamkeepers, pers. comm.). The Denil fishways are both in good condition and appear to be functioning well.

Figure 2-8. Existing fish passage enhancements in the Hastings Creek watershed: (a) Denil fishway on Hastings Creek at downstream end of culvert under Arborlynn Dr; (b) Denil fishway on Hastings Creek at upstream end of culvert under Lynn Valley Rd; (c) concrete no-post barriers used to improve fish passage on Hastings Creek under Mountain Highway bridge; and (d) wood box fish ladder on outlet channel to Hastings Creek from Donovan Pond.

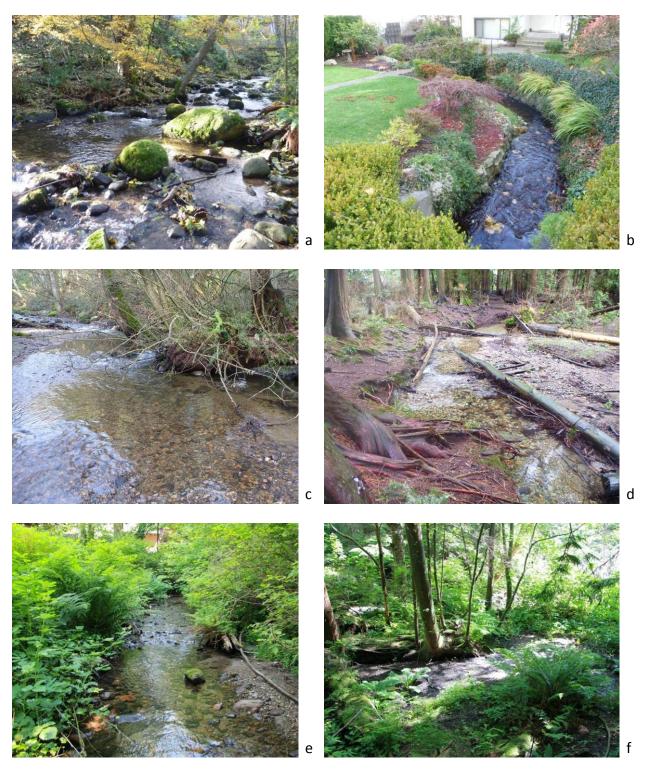
Figure 2-11. Examples of instream habitat in Hastings Creek and tributaries: (a) higher gradient boulder and cobble dominated channel in lower Hastings Creek; (b) heavily modified section of Coleman Creek with loss of riparian forest; (c) high quality spawning habitat on Hastings Creek adjacent to Ross Road School; (d) complex rearing habitat (large wood and pools) found within Hastings Creek (e) spawning habitat in Coleman Creek; and (f) off-channel habitat on Hastings Creek opposite Ross Road School.

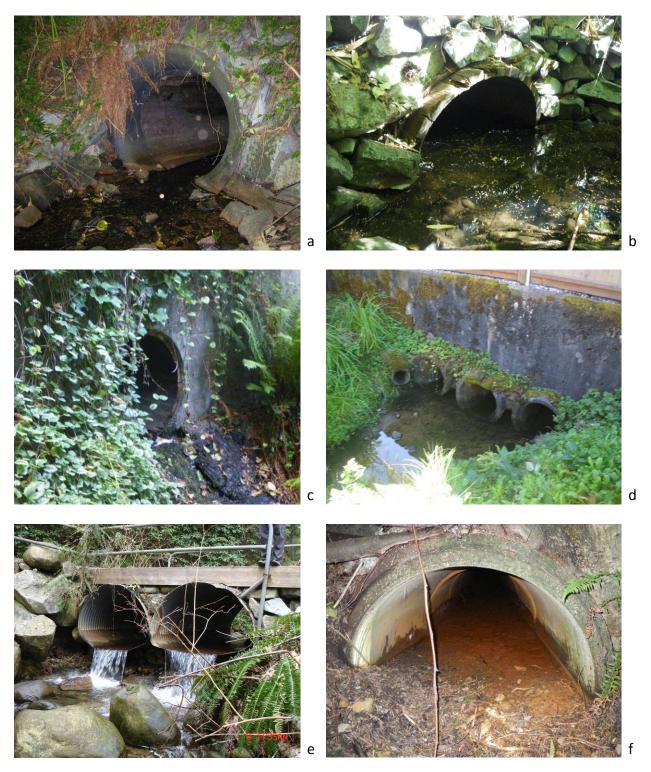
The culvert assessment described above identified 27 culverts that would not convey the 200-year flood event (Figure 3-14). These culverts could all be upgraded; however, debris management and potential blockages could occur at any culvert location in an unpredictable manner. In order to assess flood potential, the location of the culvert crossings have been coupled with a spatial assessment of topography. The District has acquired high resolution Lidar mapping. Lidar is generally found to provide high quality mapping with general accuracy or resolution of less than 0.1 m horizontally and between 0.1 m and 0.3 m vertically.

Figure 3-13. Examples of culvert crossings requiring upgrade or replacement: (a) inlet at Hoskins Creek at Kilkenny – note some inlet improvements; (b) outlet at Hoskins at Kilkenny – note backwater; (c) Coleman Creek at McNair – undersized and woodstave; (d) Hoskins at Ross Road – undersized (e) Thames Creek at Mill Street structural issues; and (f) Thames tributary at Dempsey Road – requires maintenance.

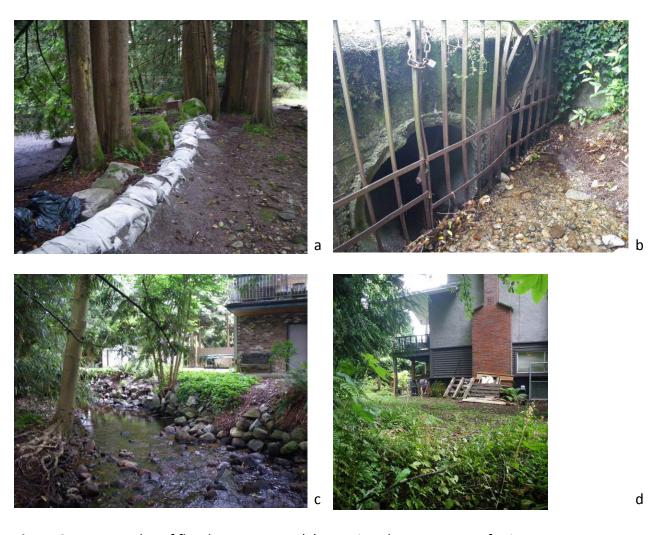
Figure 3-15. Examples of flood prone areas: (a) at Twin Lakes upstream of Princess – note sandbagging in recent season; (b) inlet on Kilmer Creek at Fredrick Road, prone to blockage and across from Argyle School; (c) house a short distance from Hastings Creek, with limited containment (near Argyle School); (d) Older home downstream of Argyle School, with below grade basement adjacent to Hastings Creek.

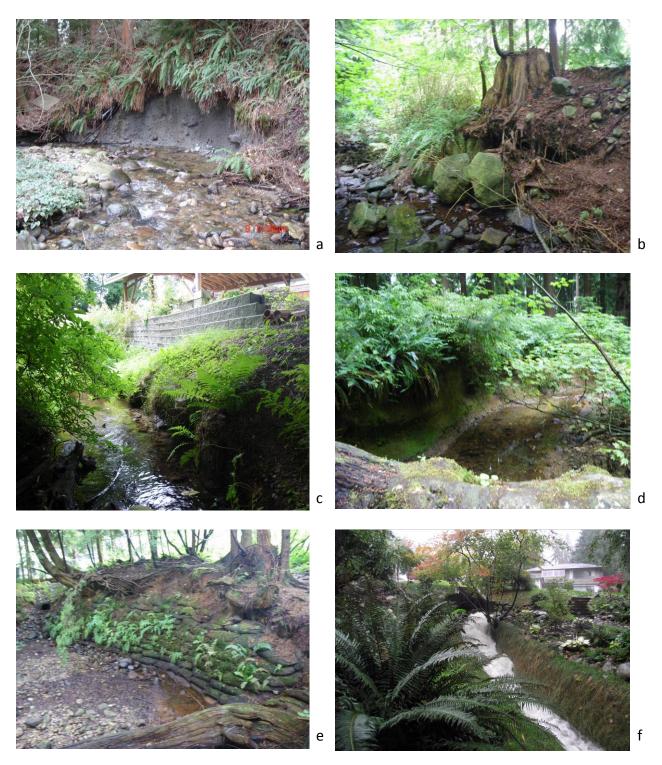
Figure 3-18. Examples of erosion and bank protection: (a) exposed till slope on Thames Creek downstream of Dempsey; (b) Hastings Creek upstream of Princess typical erosion; (c) erosion in Thames Creek upstream of Ross Road - erosion threatening retaining wall and carport; (d) Typical undercut erosion in Hunter Park – likely more beneficial as fish habitat and is not a priority site for bank protection; (e) Deltalok slope in Hunter Park, a balance between traditional protection and large habitat structure enhancement; (f) Deltalok slope on Coleman Creek at Mill Street – note high flows shown above resulted in damage.

For the bridge sites, relatively conventional protection should be undertaken, unless restricted by access (likely for one site). Many of the trail erosion sites could utilize a habitat structure style bank protection, incorporating large wood elements, boulder elements and live planting. The 12 erosion sites are mapped on Figure 3-17 (Appendix 1: Map 21) along with the high consequence private sites.
