SUBJECT: District of North Vancouver Drinking Water Quality Annual Report, 2014.

**NORTH VANCOUVER
DISTRICT**

DRINKING WATER QUALITY ANNUAL REPORT

2014

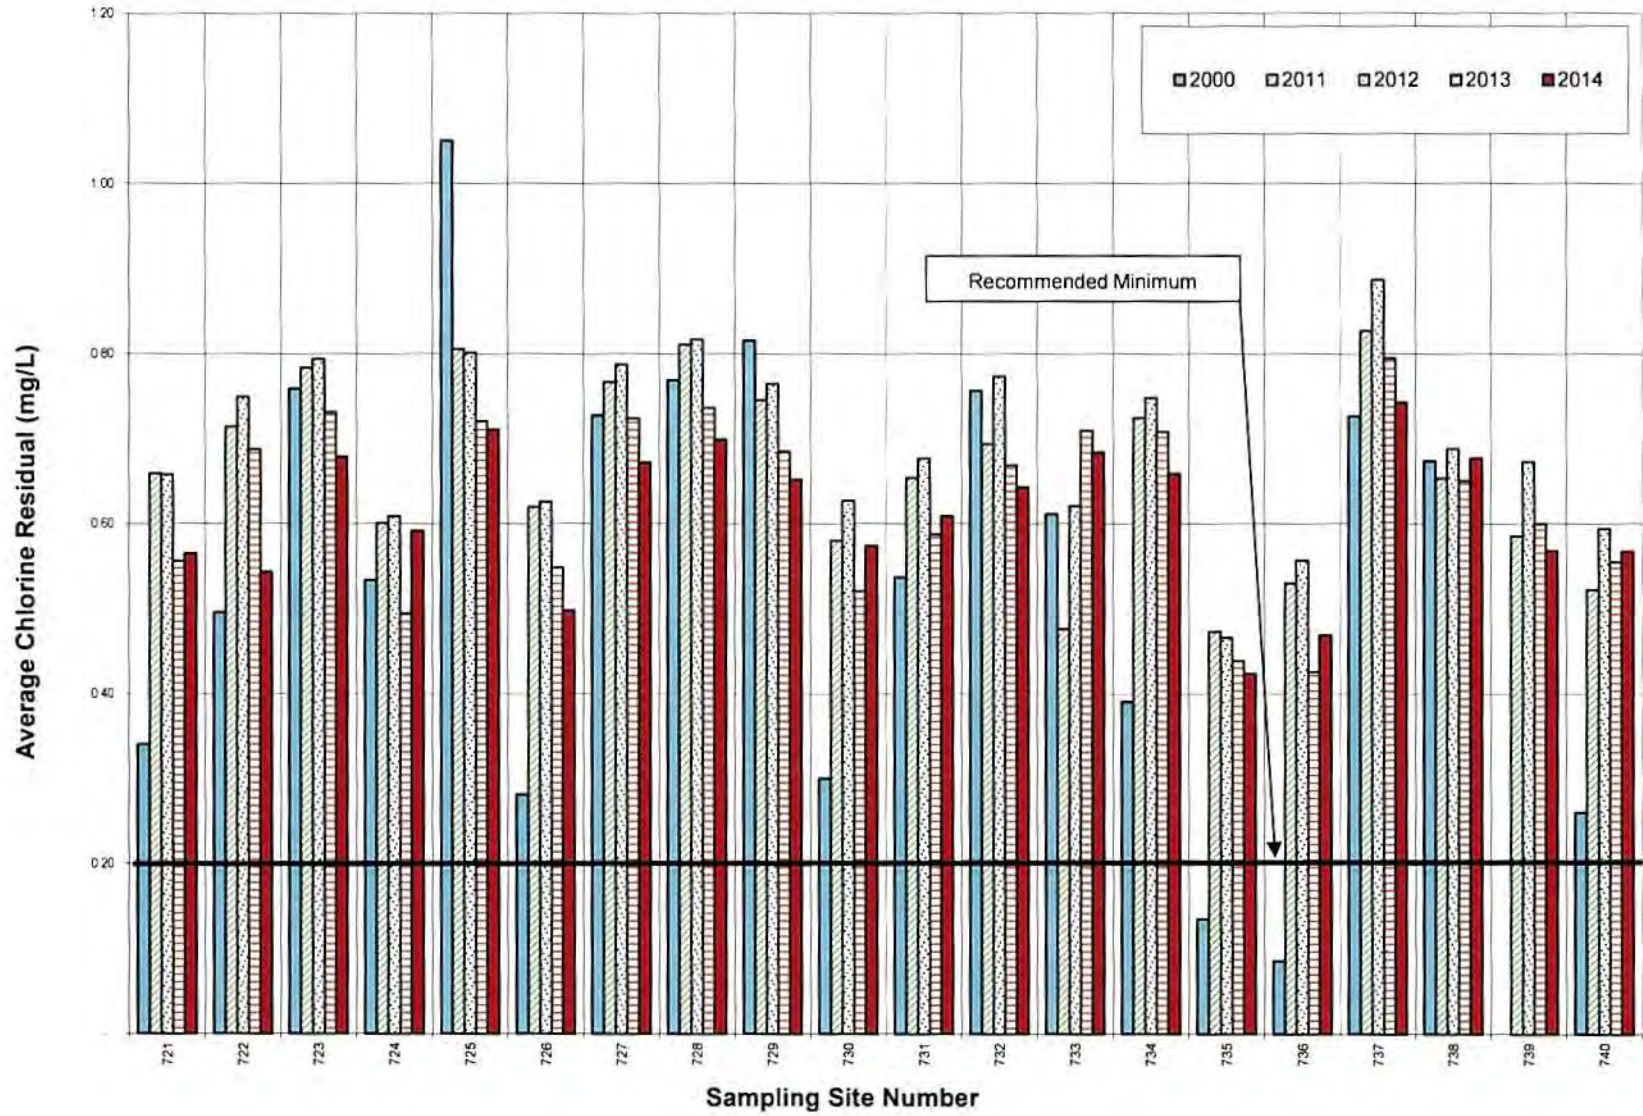
District of North Vancouver Drinking Water Quality
 2000, 2011, 2012, 2013 and 2014 Chlorine Residuals for DNV Sampling Sites 721 - 740

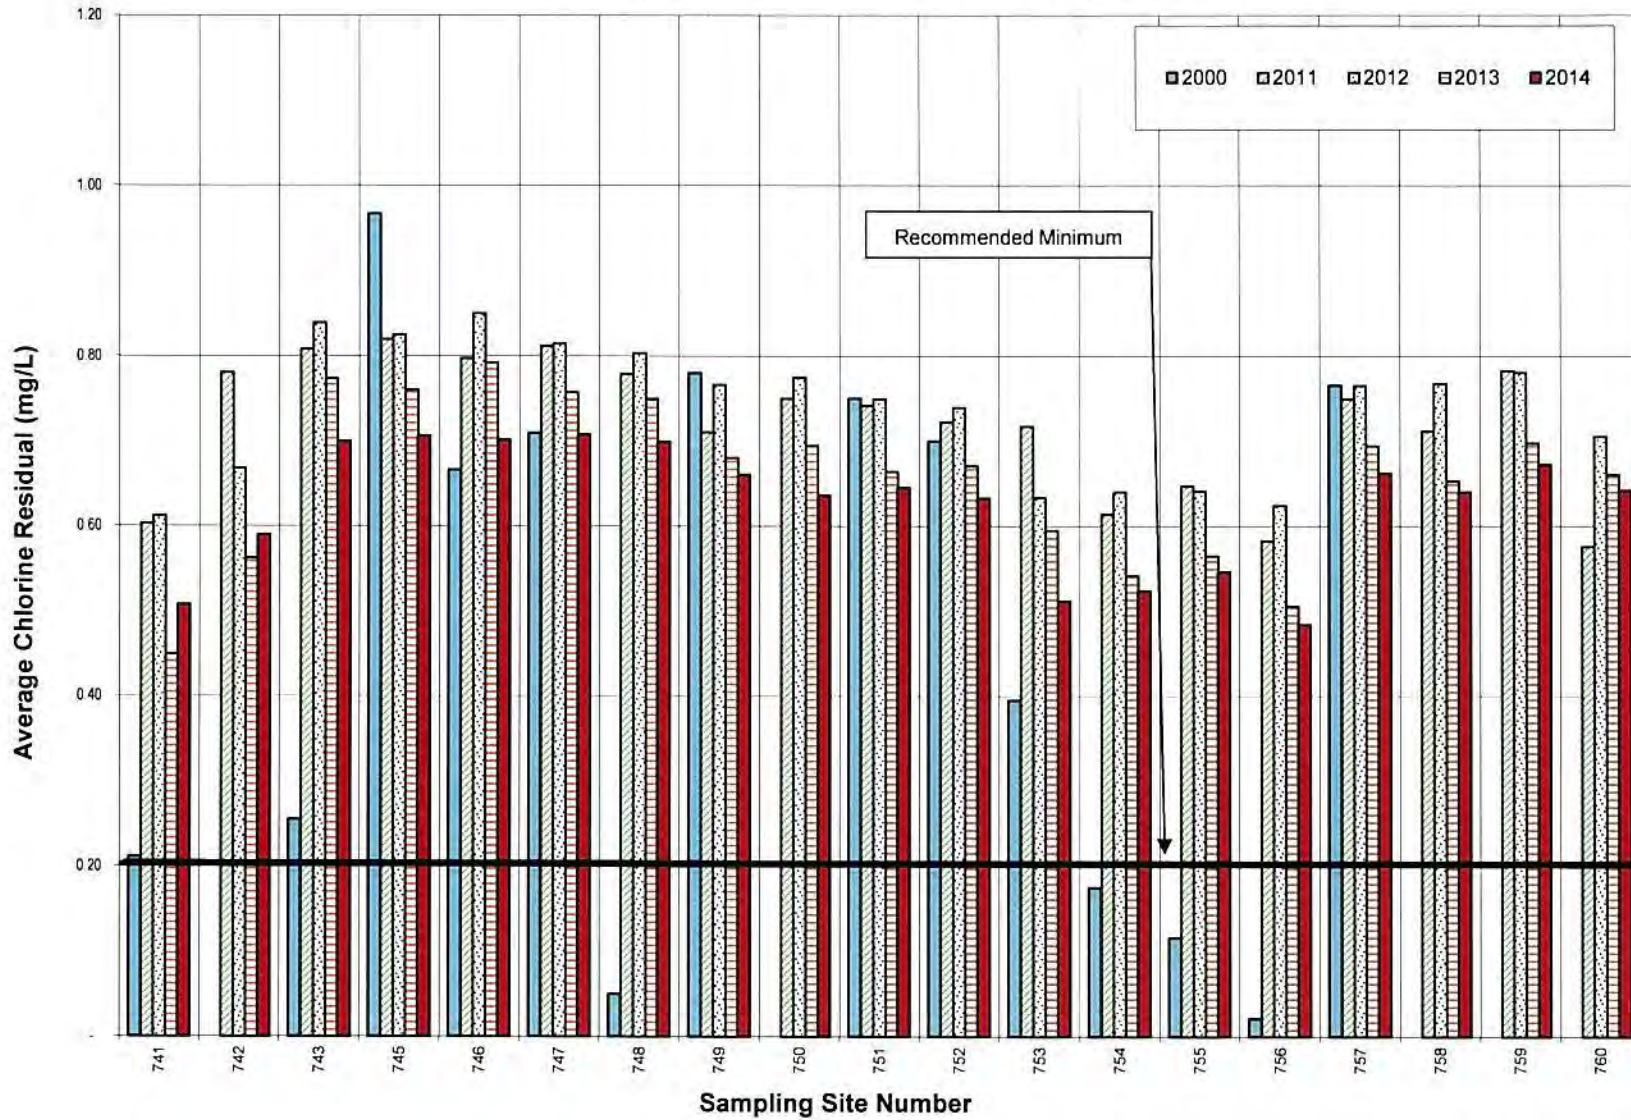
District of North Vancouver Drinking Water Quality
 2000, 2011, 2012, 2013 and 2014 Chlorine Residuals for DNV Sampling Sites 741 - 760

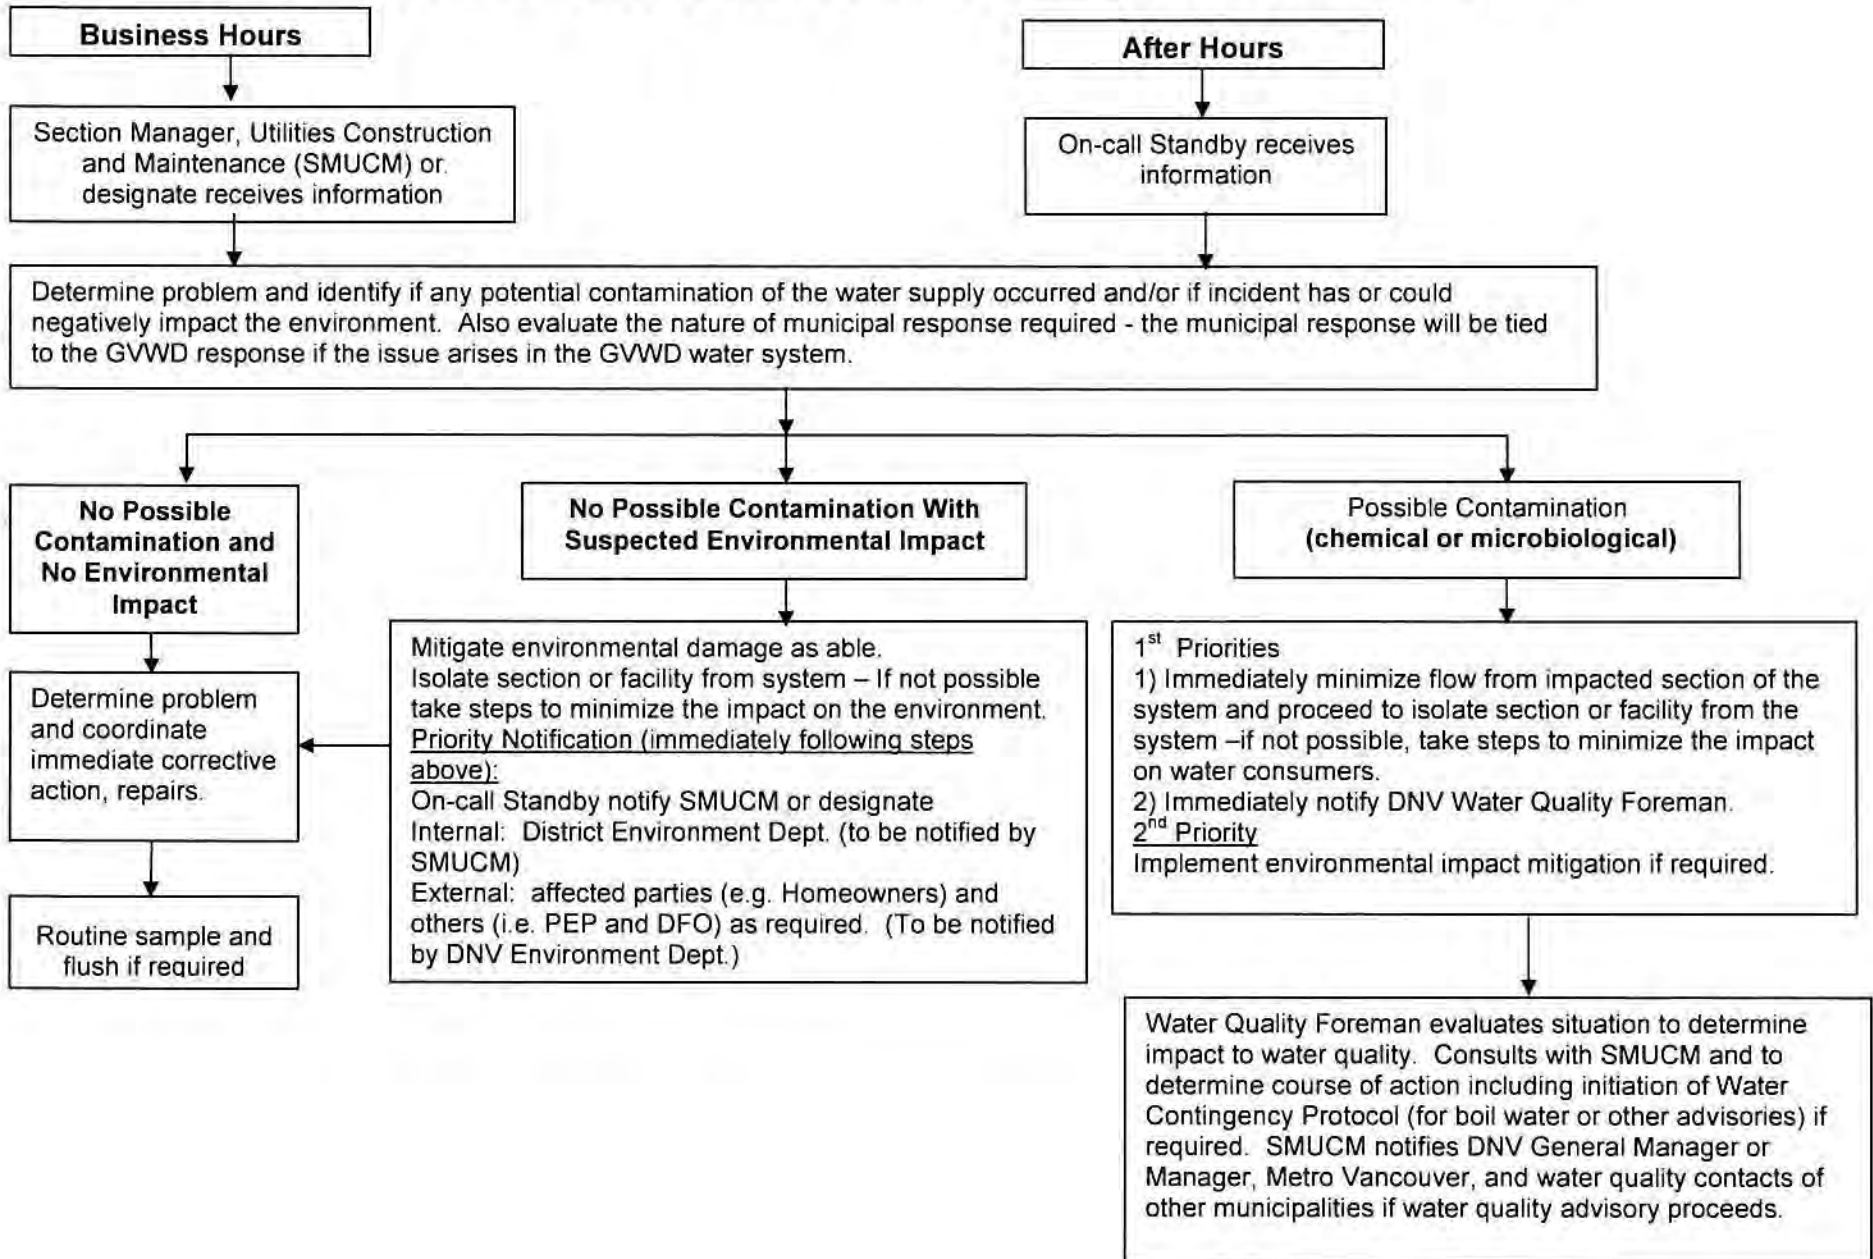
**District of North Vancouver Response Procedures For Loss of Municipal System Integrity
(Line breaks, vandalism, loss of pressure, chemical or microbiological contamination)**
