**NORTH VANCOUVER**  
**DISTRICT**

# 2022 ANNUAL DRINKING WATER QUALITY REPORT

*June 30, 2023.*

*District of North Vancouver Utilities Department*

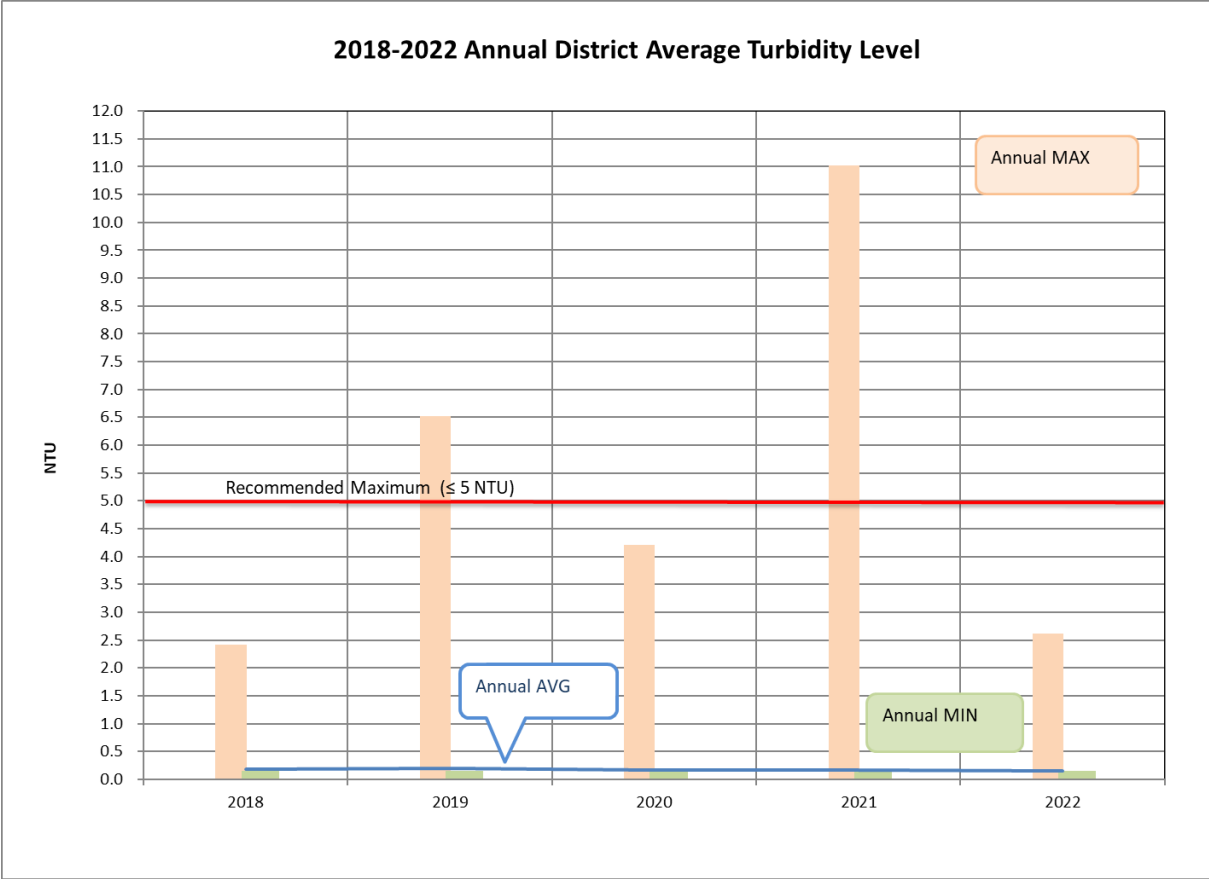
The scheduled samples collected in 2022 met the guidelines for safe potable water. There were no occurrences of detectable E. coli nor Total Coliform. Five samples were collected in 2022 with turbidity over 1.0 NTU, which were the results of unintended high flows within the system due to operational and fire-fighting activities. The sites were all resampled days following the higher reading day and were back to acceptable levels. One sample was over the HPC OG recommendation of 500 CFU/mL. Subsequent resampling resulted in normal levels. Because HPC is used as an indicator of general bacteriological quality, a single sample above 500 CFU/ml is not a cause for concern. The HPC and turbidity levels are stable over time. The annual DNV average HPC and turbidity for the last five years are presented below.

Figure 3. Turbidity Five Year Annual Average and Maximum Values.

- **Turbidity:** Particles in drinking water can inhibit treatment and indicate potential quality concerns. The Guideline suggest an OG of supply water turbidity target of < 1 Nephelometric Turbidity Unit (NTU) or "best possible" and should not exceed 5.0 in distribution systems.

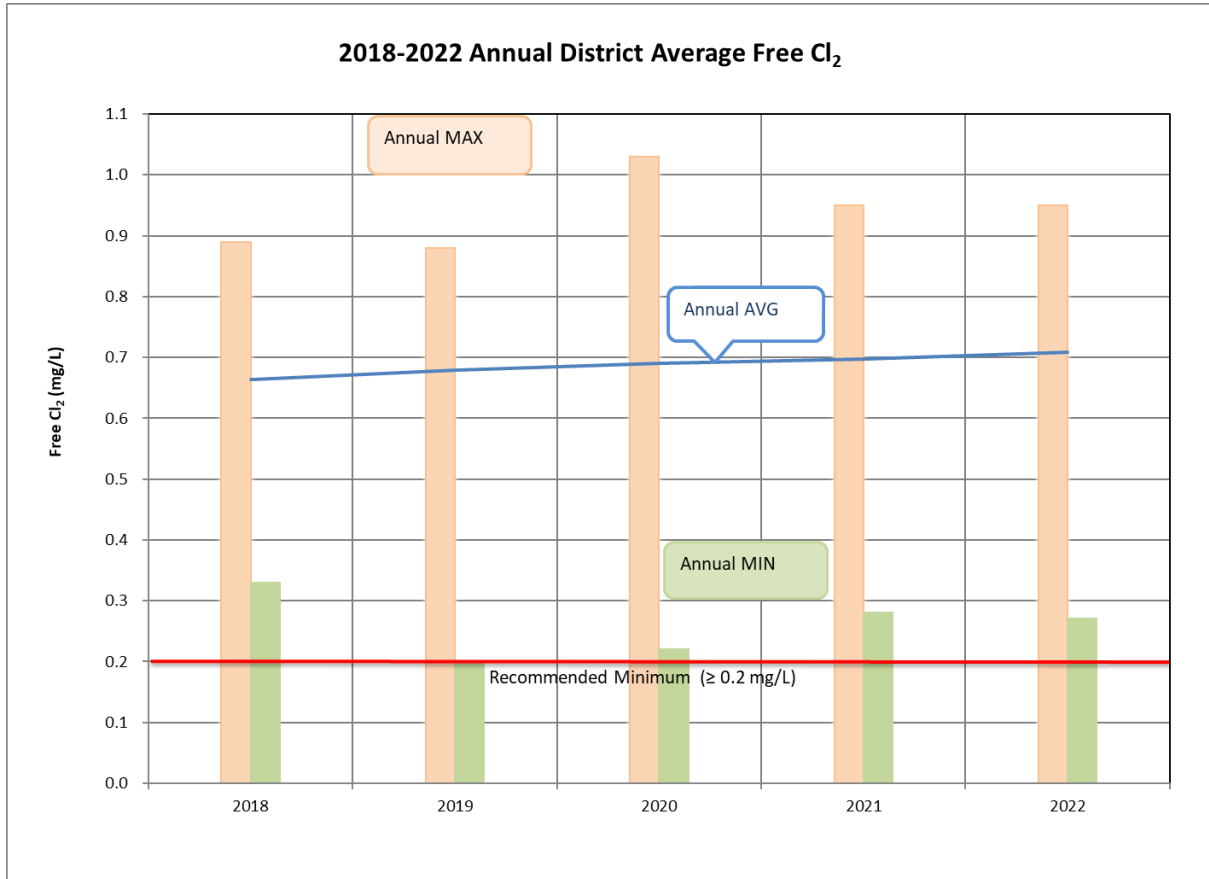
- Chlorine:** Chlorine is used in the disinfection process, and a residual amount in the distribution system is desirable to maintain potable water quality. In 2022, all samples were within the OG range for residual chlorine, 0.04-2.0 mg/L and above the OG of 0.2 mg/L. The average system-wide chlorine residual was 0.71 mg/L. The minimum recorded chlorine residual was 0.27 mg/L. The maximum recorded chlorine residual was 0.95 mg/L. The annual DNV average free chlorine for the past five years is presented below in Figure 4.

Figure 4. Free Cl<sub>2</sub> Five Year Annual Minimum, Average and Maximum Values.

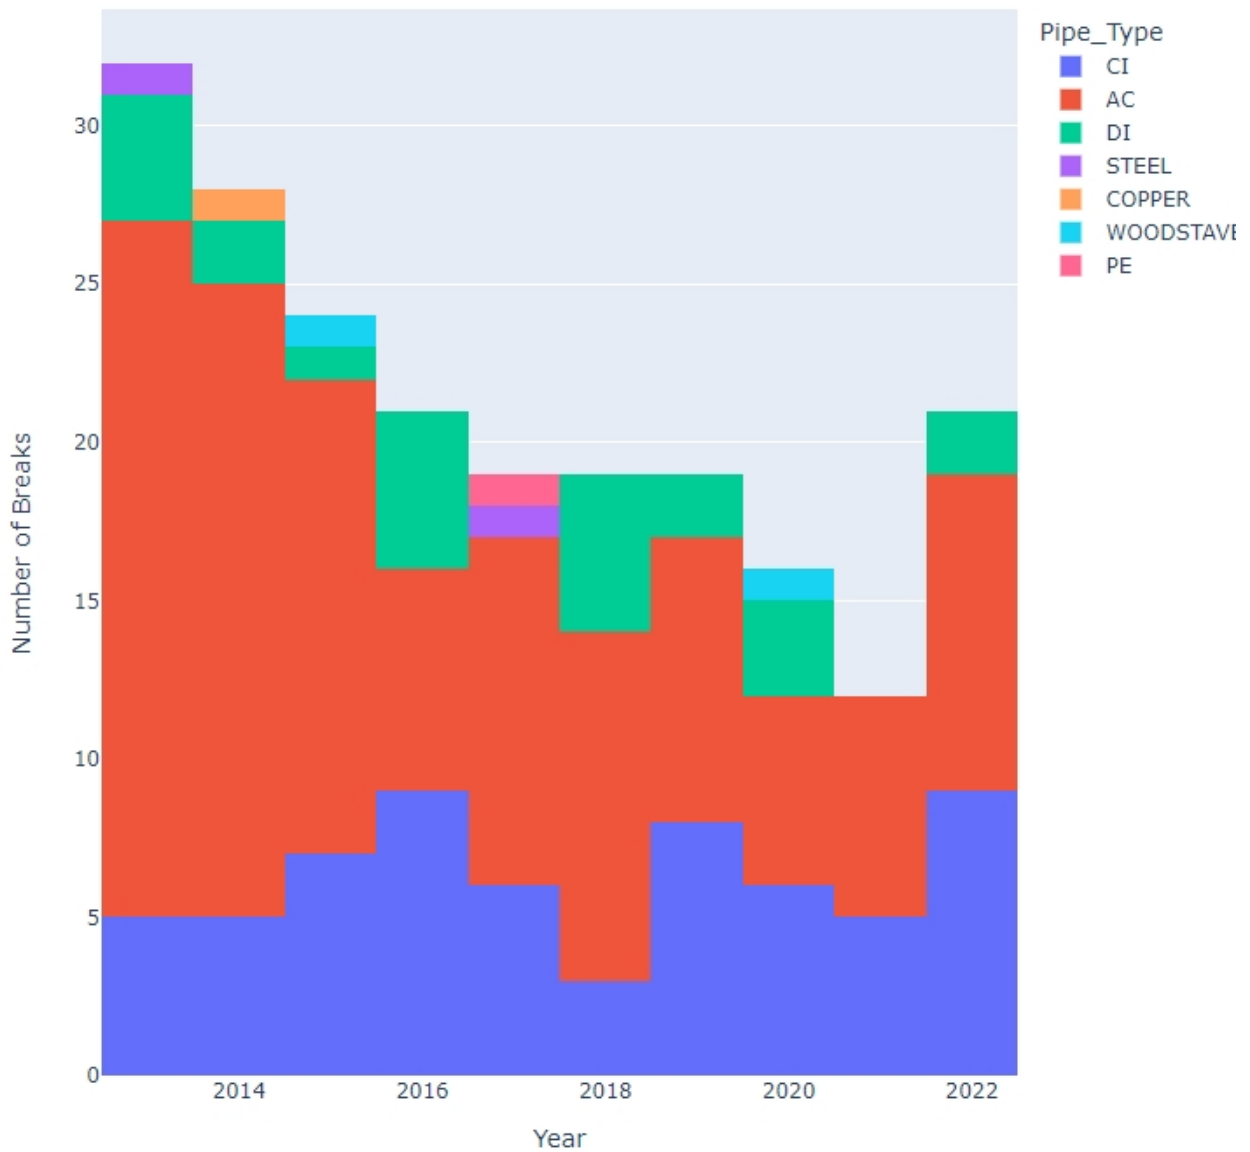
We responded to 21 emergency water main breaks in 2022. Water main break response protocol includes maintaining positive pressure to protect the water system from potential contamination. The number of breaks in 2022 was up from previous years and countered the ten-year trend of declining breaks due to our replacement program eliminating more of the asbestos cement pipe which is most prone to failure. We expect the trend to normalize in 2023 and continue the downward trend or at least maintain the lower levels from past years where it surpassed 30 breaks per year.

Figure 6. 10-Year Water Main Break Summary

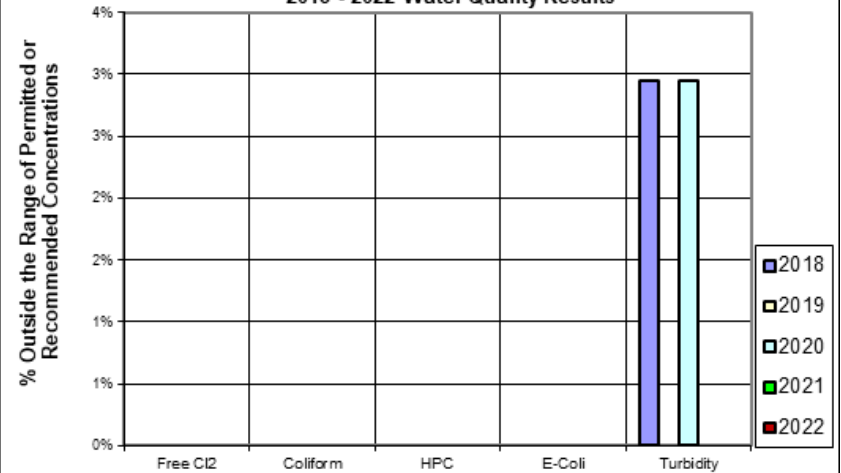
Site 756 - End of Fire Lane # 7, Firelane #7 - 3.6 km from Hixon Rd.  
2018 - 2022 Water Quality Results
