HASTINGS CREEK WATERSHED:

Ecology and Hydrotechnical Assessment

June 2013

Prepared for: **District of North Vancouver**

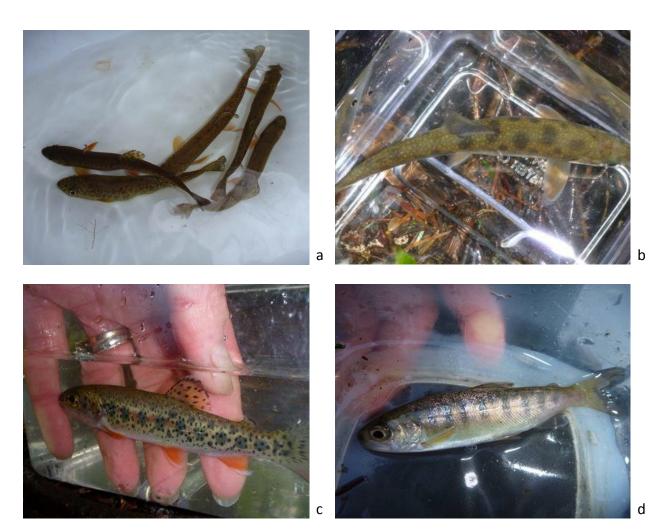
Figure 2-6. Examples of fish captured during minnow trapping survey in spring 2012: (a) Cutthroat Trout in Thames Creek from plunge pool below Lynn Valley Rd culvert; and (b) Dolly Varden captured in culvert plunge pool on Hastings Creek below Arborlynn Dr; (c) Cutthroat Trout from Doran Park; and (d) juvenile Coho Salmon from Hastings Creek.

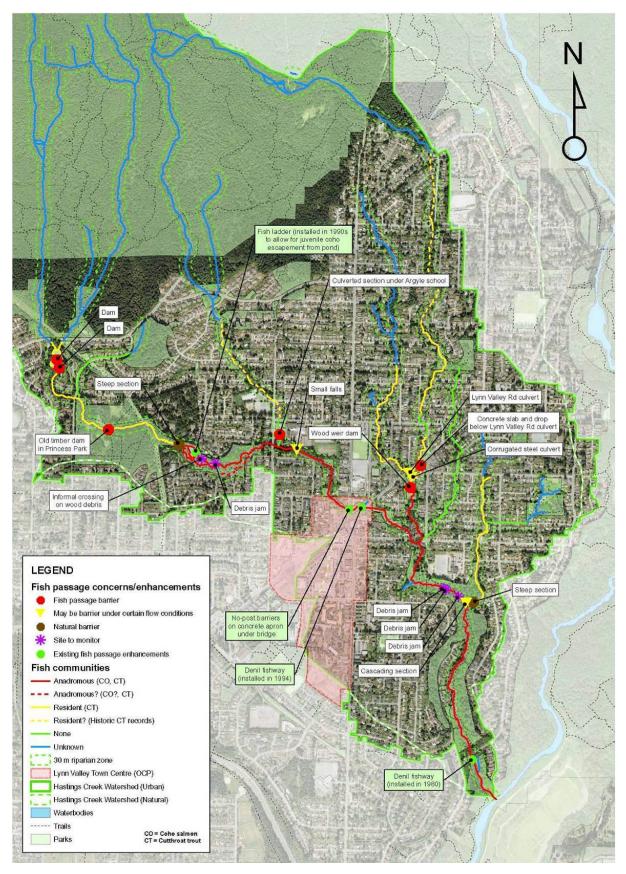
Figure 2-9. Fish passage barriers in the Hastings Creek watershed.

Several debris jams and steep sections were mapped as being possible barriers to fish passage under certain flow conditions and were identified as concerns by the North Shore Streamkeepers (see Figure 2-9 and Appendix 1: Map 8). Debris jams may limit fish passage under some flow but they also provide an important function by creating complex habitat. Steep sections identified were naturally occurring features, such as a cascades and a small falls. All sites were deemed as sites to monitor but are not considered impediments to fish passage at this time.

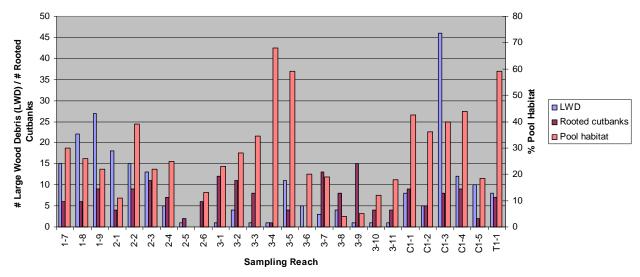
- Pool habitat is also generally lacking throughout the sections sampled, including the
 reference section, except for a very small number of segments (Figure 2-14). Mean %
 pool habitat ranged from 0% to 68% (mean = 28%). Existing pools were often a result of
 unique conditions rather than the presence of natural pool-forming features such as
 large wood debris and boulders.

Figure 2-14. Distribution of large instream wood (LWD), rooted cutbanks, and pools in selected stream segments of Hastings Creek and major tributaries.

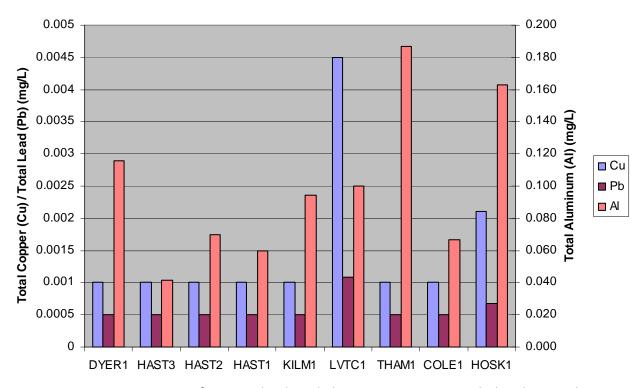
- Total aluminum in water above CWQGs at the two reference sites above development (Thames Creek and Dyer Creek) and in Hoskins Creek (Figure 2-16). Dissolved aluminum was also above BCWQGs in Thames Creek at Mountain Highway, upstream of the urban development boundary. This suggests the underlying geology of the watershed may lead to naturally high aluminum levels in creeks in the watershed.

Figure 2-16. Concentrations of copper, lead, and aluminum at sites sampled in dry weather on May 18, 2012.

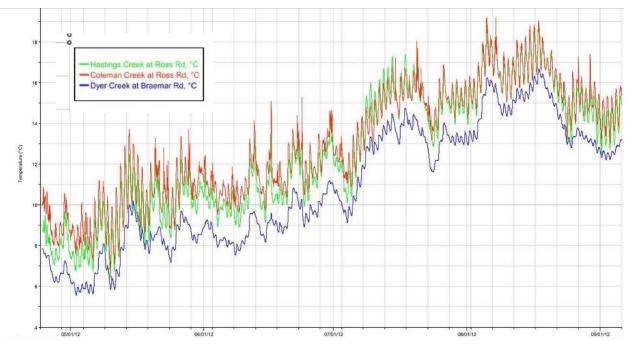
Monitoring showed two noteworthy results. First, Hastings and Coleman creeks have very similar temperature patterns with a relatively strong diurnal signal of up to 2.5°C during warm weather. Dyer Creek (blue line in Figure 2-17) is generally cooler and more stable. Second, the maximum temperature in the summer of 2012 was around 19°C. This is higher than the recommended range for salmon and trout habitat but below levels which cause mortality.

Figure 2-17. Seasonal water temperature in Hastings, Dyer, and Coleman creeks (April 15 to September 10, 2012).

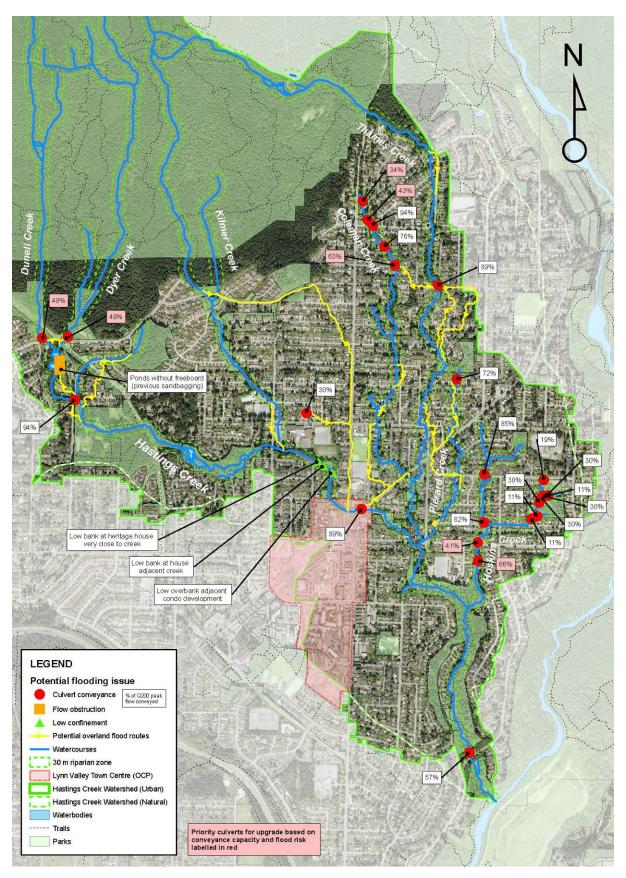
Figure 3-14. Potential flooding based on flood flow exceedance at road crossings.

Capacities were calculated for the 57 culverts, a total of 27 culverts had culverts that could not convey the 200-year return period discharge without headwater (Figure 3-14). Based on the assessment there are:

The culvert assessment described above identified 27 culverts that would not convey the 200-year flood event (Figure 3-14). These culverts could all be upgraded; however, debris management and potential blockages could occur at any culvert location in an unpredictable manner. In order to assess flood potential, the location of the culvert crossings have been coupled with a spatial assessment of topography. The District has acquired high resolution Lidar mapping. Lidar is generally found to provide high quality mapping with general accuracy or resolution of less than 0.1 m horizontally and between 0.1 m and 0.3 m vertically.

Figure 3-14 indicates that flood routes could occupy streets until the topography would suggest that the water would find a route across private properties until finding the creek channel again.

Based on capacity and condition, seven culverts have been identified as priorities for upgrading or replacement (Figure 3-13 and 3-14), where one small local drainage culvert north of Argyle School not included. An additional two culverts, Hastings Creek at Hoskins Road and Kilmer Creek at Wellington Road should be considered for regular inspection, based on age. All the culverts identified are mapped and noted on Figure 3-14. High priority culverts for upgrading are also identified and discussed in Section 4.

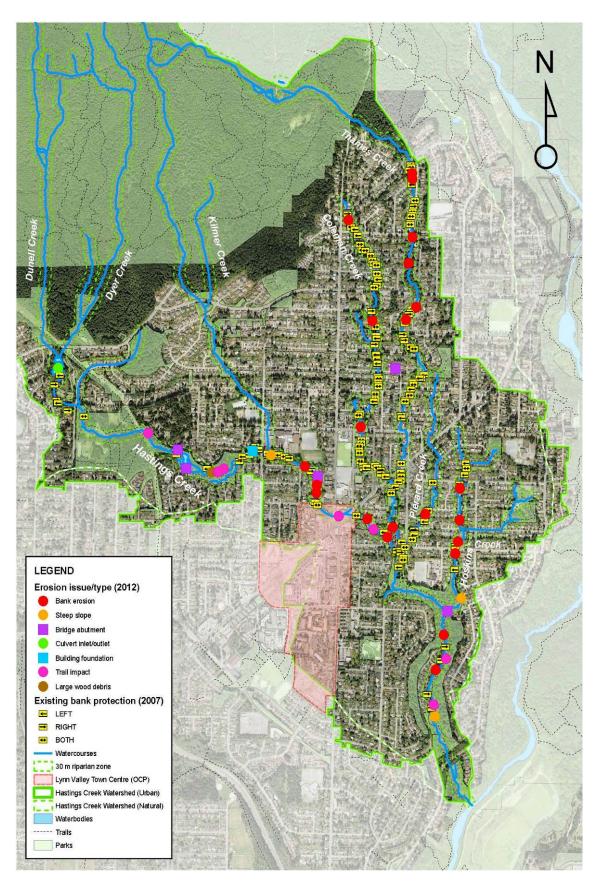
Figure 3-16. Erosion sites and existing bank protection works.

In 2007, a very detailed reconnaissance of Hastings Creek and the tributaries was conducted by KWL. All erosion sites identified are mapped on Figure 3-16 (Appendix 1: Map 19), and these are linked to a photo reference in the GIS spatial database. The inventory resulted in the identification of 248 erosion sites of varying hazard and consequence. Erosion hazard was identified in terms of erosion height where:

- Low Hazard: Less than 0.3 m high;
- Moderate Hazard: between 0.3 m and 1.2 m high; and
- High Hazard: Higher than 1.2 m.

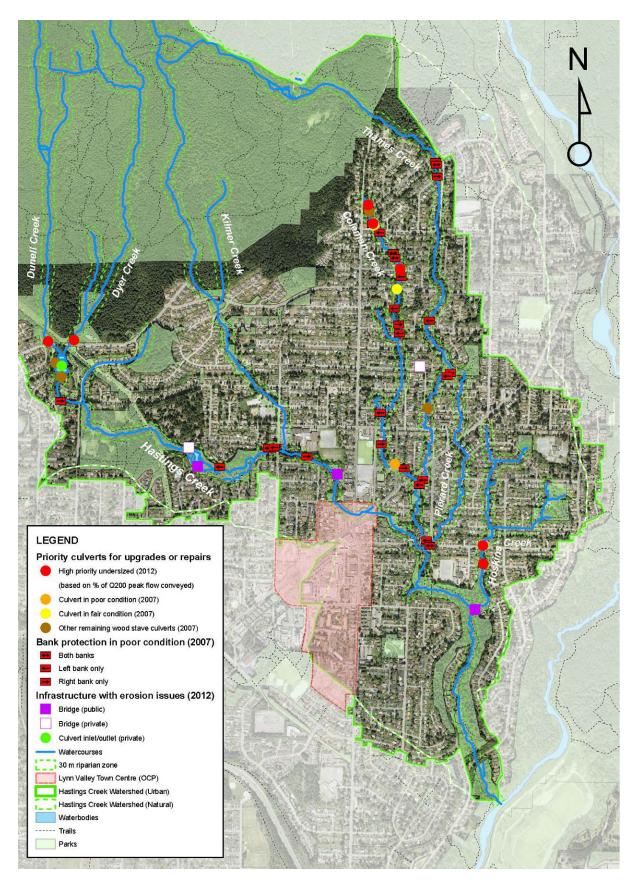
Figure 3-17. Priority infrastructure for upgrades and repairs.

A total of 12 sites of high consequence were identified for District assets, three footbridge sites and nine trail sites (see examples in Figure 3-18). Many of the trail sites were identified in Hunter Park, where the lack of defined trail system has led to encroachment on the creek.

For the bridge sites, relatively conventional protection should be undertaken, unless restricted by access (likely for one site). Many of the trail erosion sites could utilize a habitat structure style bank protection, incorporating large wood elements, boulder elements and live planting. The 12 erosion sites are mapped on Figure 3-17 (Appendix 1: Map 21) along with the high consequence private sites.

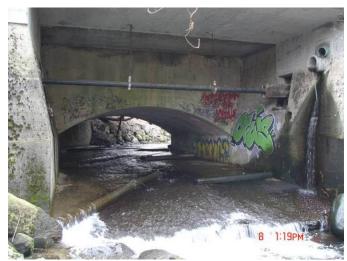
(a) Current off-set fish baffles under Mountain Highway

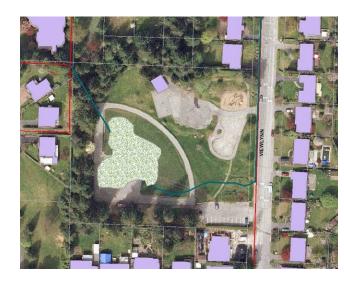
(b) Concept for LID facility at Viewlynn Park – proposed surface and subsurface facility with new stormmain along Viewlynn Road

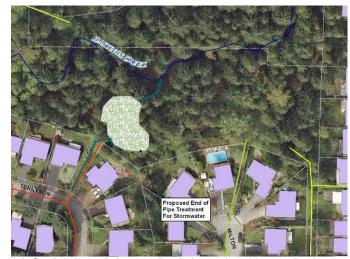
(c) Outfall from Princess Park (south) at Hunter Park – Proposed treatment wetland and possible off channel habitat

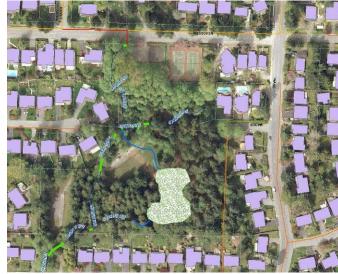
(g) Concept for attenuation facility in Draycott Park – some storm sewer work on Westover Road could move more discharge here.
